Re: Boonton Railroad Bridge

PKB Engineering conducted an inspection of the abandoned railroad bridge over the Rockaway River in the Town of Boonton on April 30, 2019 to assess the current condition of the bridge. The following is a summary of our inspection findings, load rating analysis, recommendations for repairs and deficiency photos. Structural elements were checked for general condition and field measured for repairable quantities and load rating analysis. Photographs were taken of typical deficiencies and are attached. Findings were evaluated to determine repairs needed to return the bridge to both rail and pedestrian use.

Structure: Boonton Railroad Bridge
Inspection Date: 4/30/2019

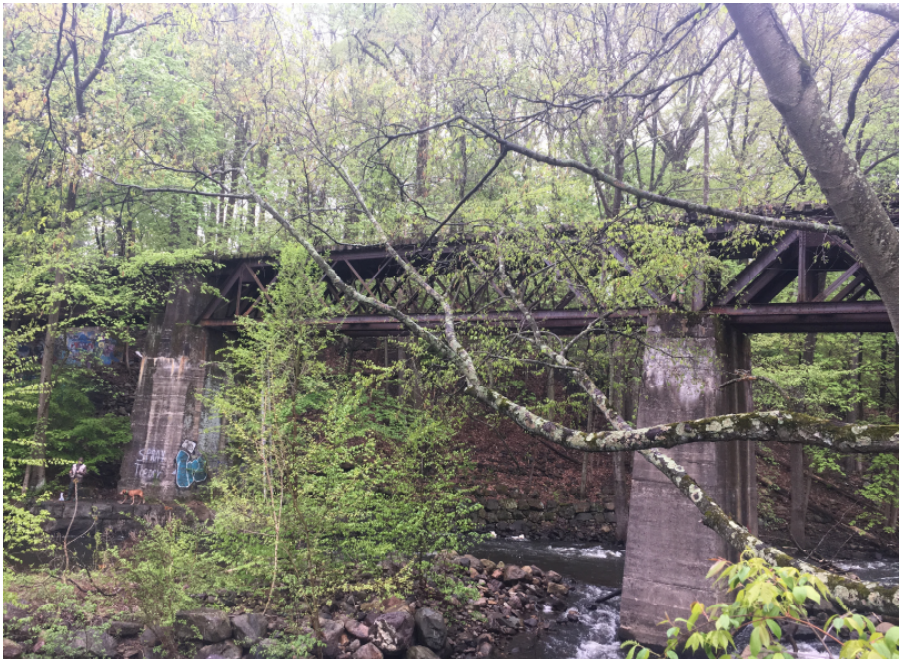
Photo 1: East Elevation, looking west.

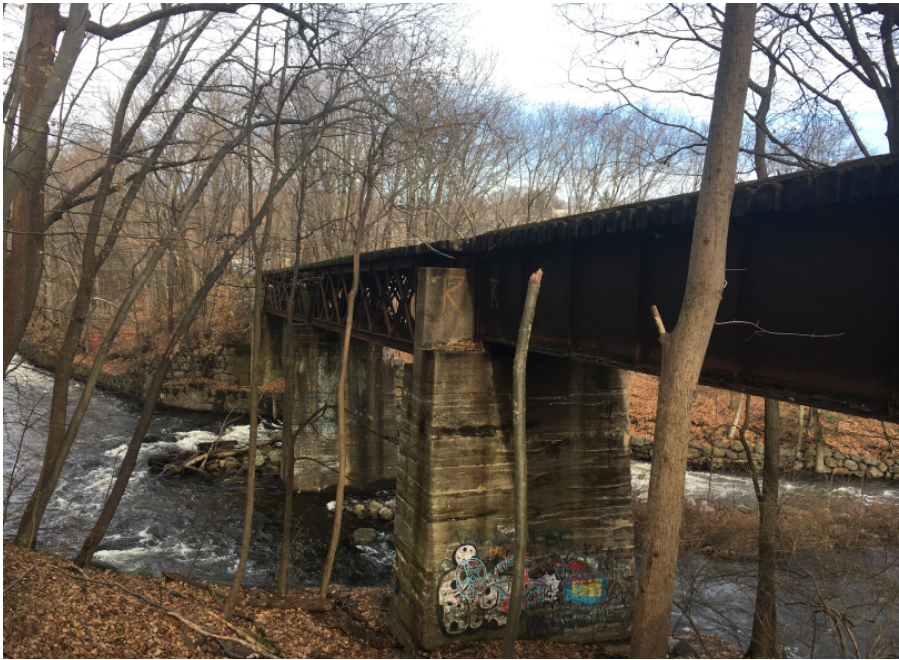
Photo 2: West Elevation, looking northeast.

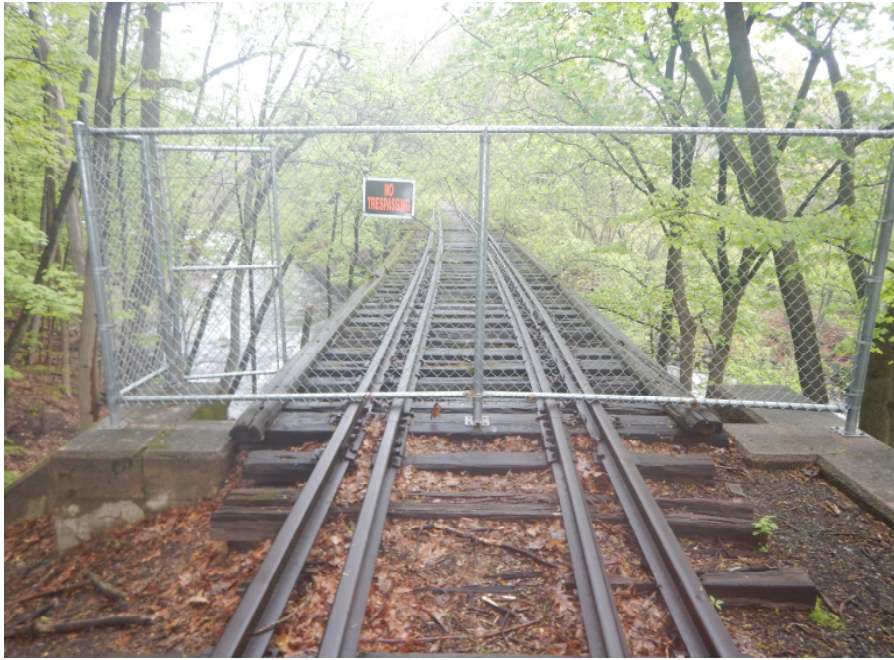
Photo 3: Track, from South Approach to bridge, looking north.

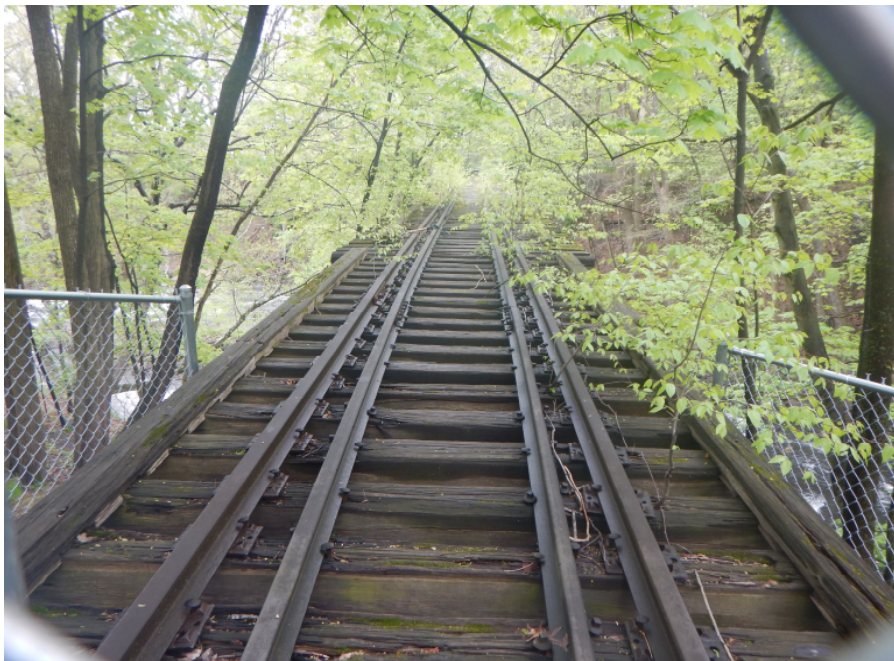
Photo 4: Track, from North Approach to bridge, Looking south.

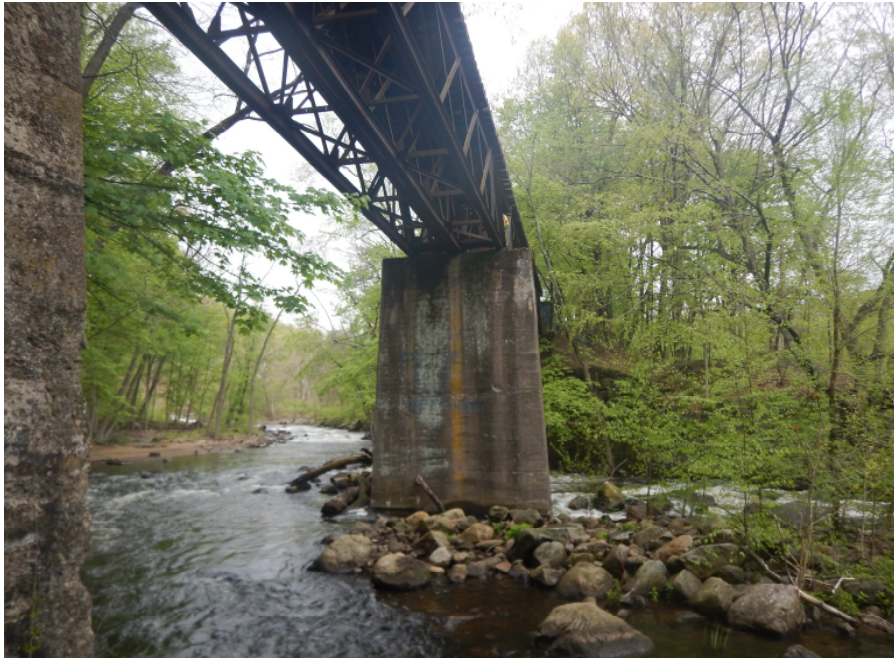
Photo 5: Upstream Channel, looking west.

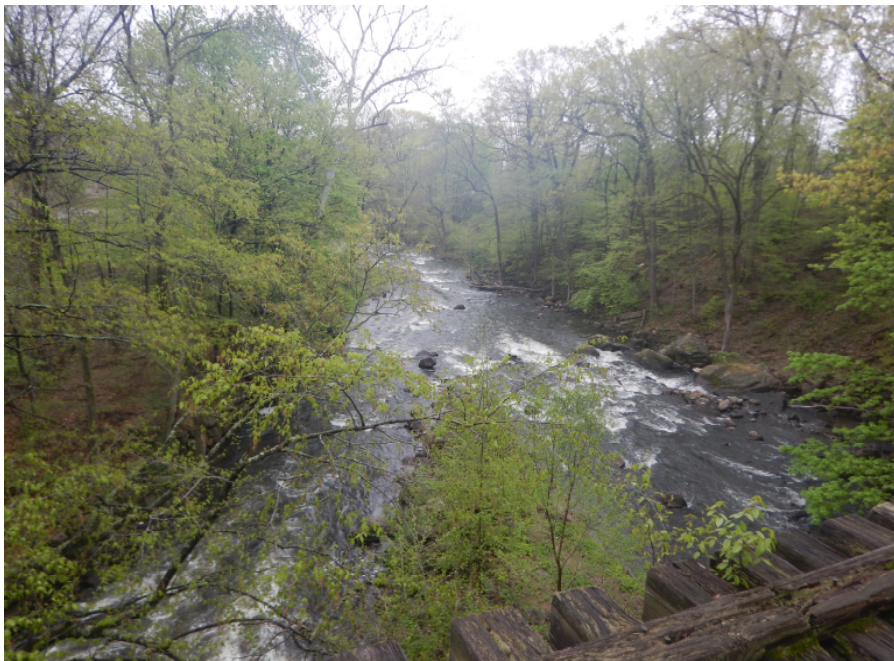
Photo 6: Downstream Channel, looking east.

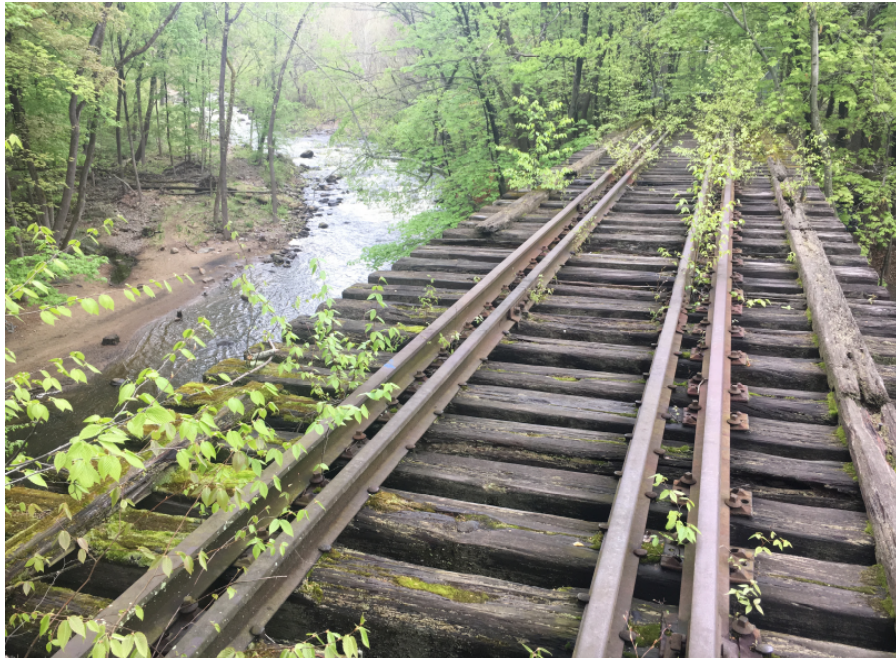
The timber bridge ties are in poor condition, due to wide spread advanced rot and decay. Several ties also exhibit fire damage (See Photos 7, 8 & 9).

Photo 7: Typical top of deck condition, severe rot and decay of timber ties with heavy vegetation growth, looking northwest.

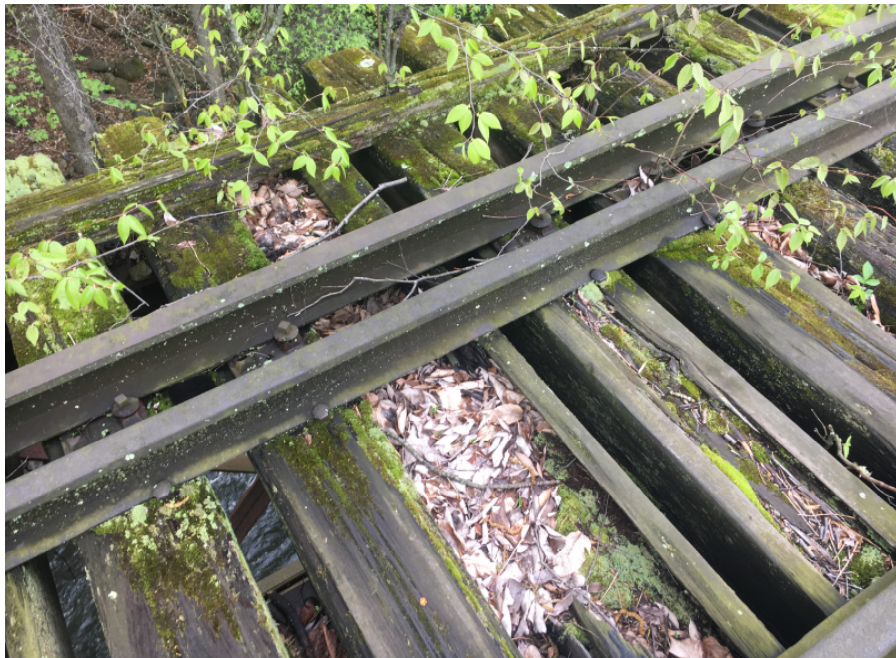
Photo 8: Severe rot and decay of timber ties, typical throughout all spans, looking west.

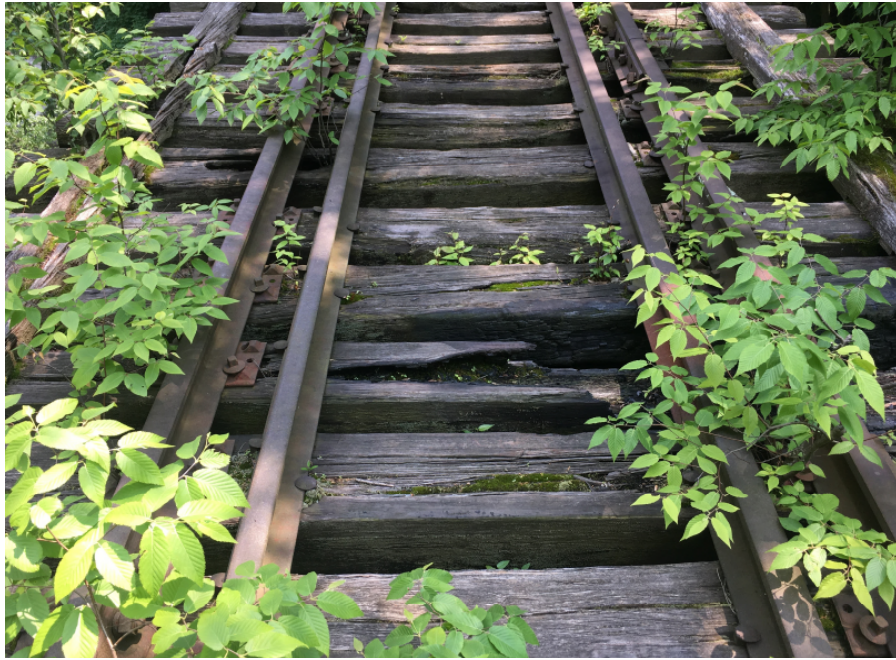
Photo 9: Fire damage to timber ties, note heavy vegetation growth, typical throughout all spans, looking south.

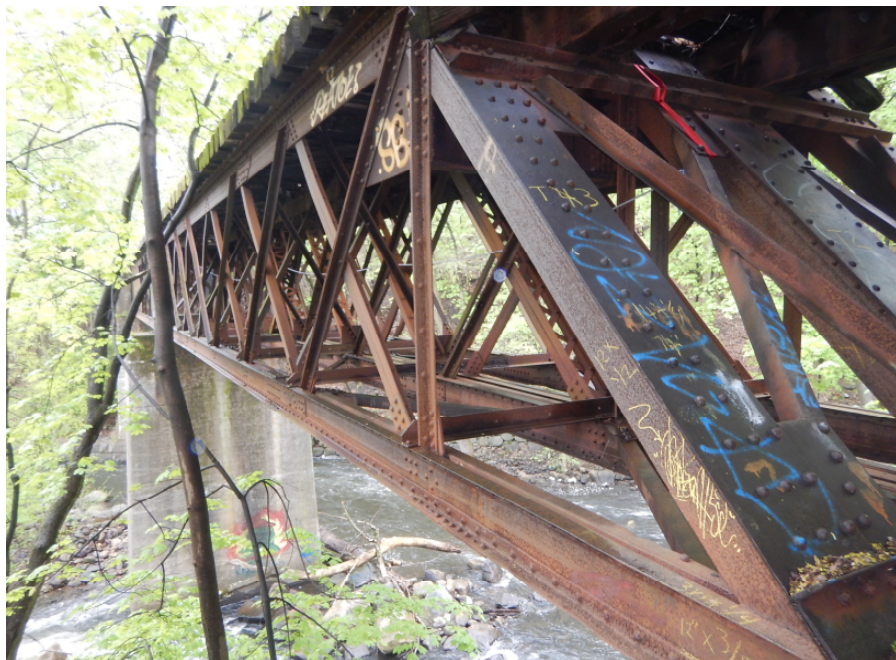
The truss members are comprised of steel angles and plates riveted together to form the truss spans. The members exhibit moderate to severe corrosion, with up to 1/16" section loss typical at riveted connections and horizontal surfaces (See Photo 10). Several members exhibit up to 100% section loss to the horizontal surfaces particularly along the lower chord members. The following is a list of truss members with significant section loss:

Photo 10: Typical condition of East Truss, Span 3, looking south. Note 100% paint loss with light to moderate corrosion of all exposed steel surfaces. Note graffiti on steel truss members.

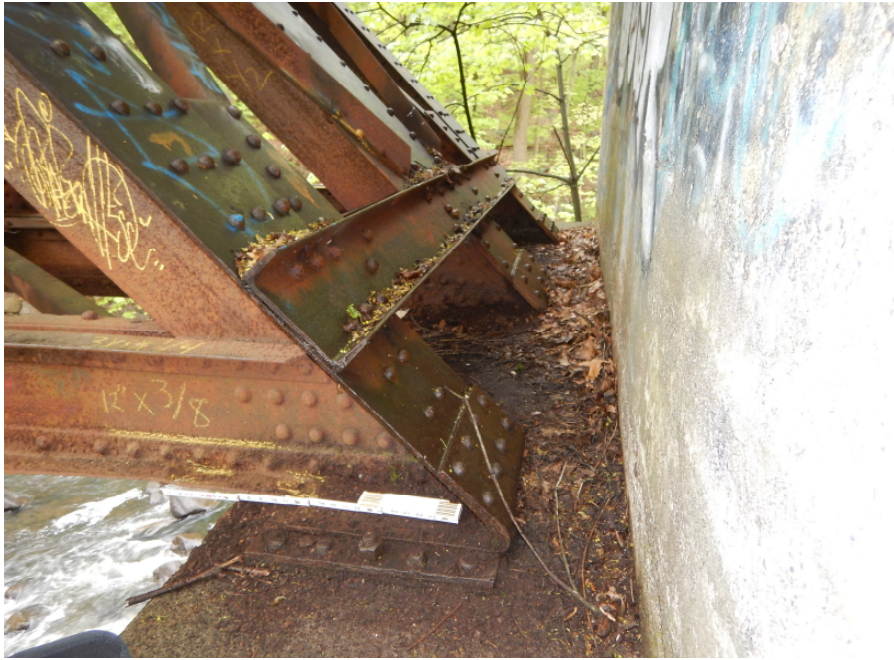
Photo 11: Severe corrosion and section loss with hole in angle leg at Span 3, East Truss, lower chord member L7L8 at L8, looking west on Pier 3.

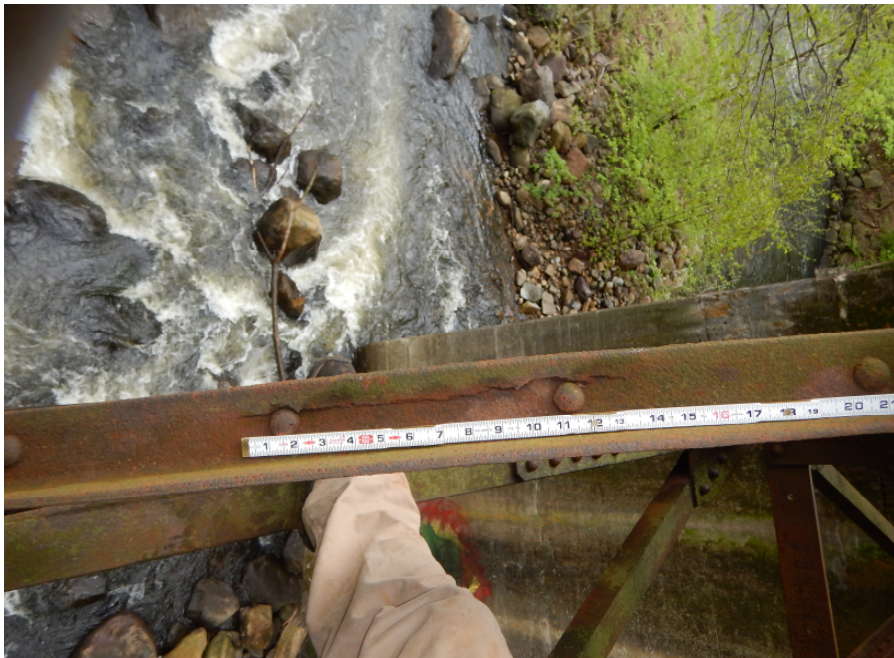
<u>Span</u>	<u>Truss</u>	<u>Truss Member</u>	<u>Condition</u>
2	1 (west)	LoL1	100% section loss to horizontal angle legs (Photo 19)
2	1	L1L2	100% section loss to horizontal angle legs
2	1	L7L8	10" long corrosion crack to horizontal angle leg (Photo 17)
2	2 (center)	L0L1	100% section loss to horizontal angle legs (Photo 14)
2	2	L7L8	100% section loss to horizontal angle legs
2	2	L1L2	1/8" section loss to both angle legs (Photo 15)
2	2	L6L7	Horizontal angle leg cracked and bent from impact
2	3 (east)	LoL1	100% section loss to horizontal angle legs
3	1 (west)	L8U7	1/8" section loss at L8
3	1	L7L8	100% section loss to horizontal angle legs
3	2 (center)	L7L8	100% section loss to horizontal angle legs
3	2	L6L7	1/8" section loss to all angle legs
3	3 (east)	L7L8	100% section loss to horizontal angle legs (Photo 11)
3	3	L6L7	100% section loss to horizontal angle legs
3	3	L3U2	13" long corrosion crack to horizontal angle leg (Photo 12)

Photo 12: 13" long crack in horizontal leg of Span 3, East Truss diagonal member L3U2, looking down.

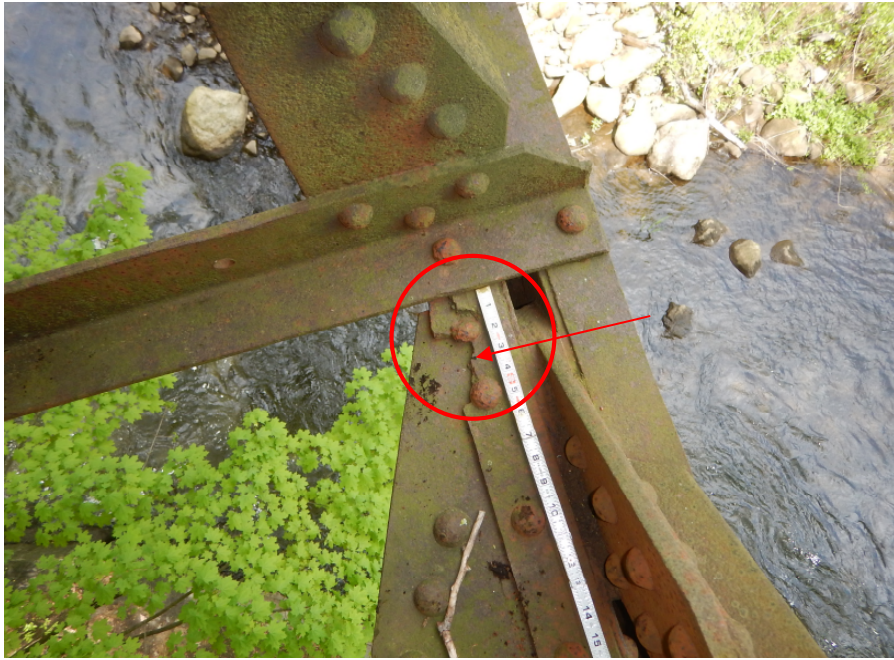
3	3	L1L2	100% section loss to horizontal angle legs (Photo 13)

Photo 13: 100% section loss to horizontal angle leg of Span 3, East Truss lower chord member L1L2 at L2, looking down.

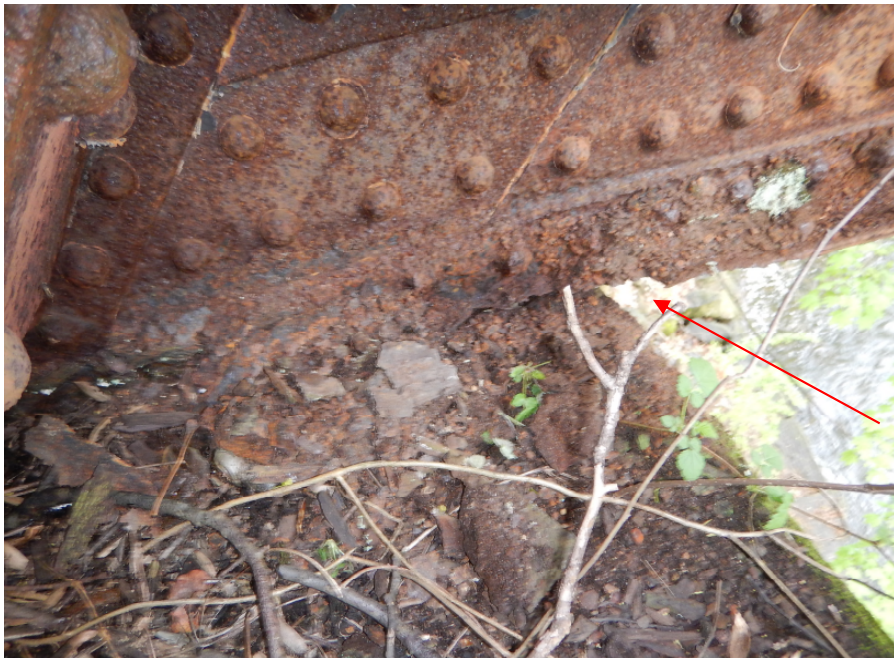
Photo 14: 100% section loss to horizontal angle leg of Span 2, Center Truss lower chord member LOL1 at L0, looking west. Note heavy debris around bearing.

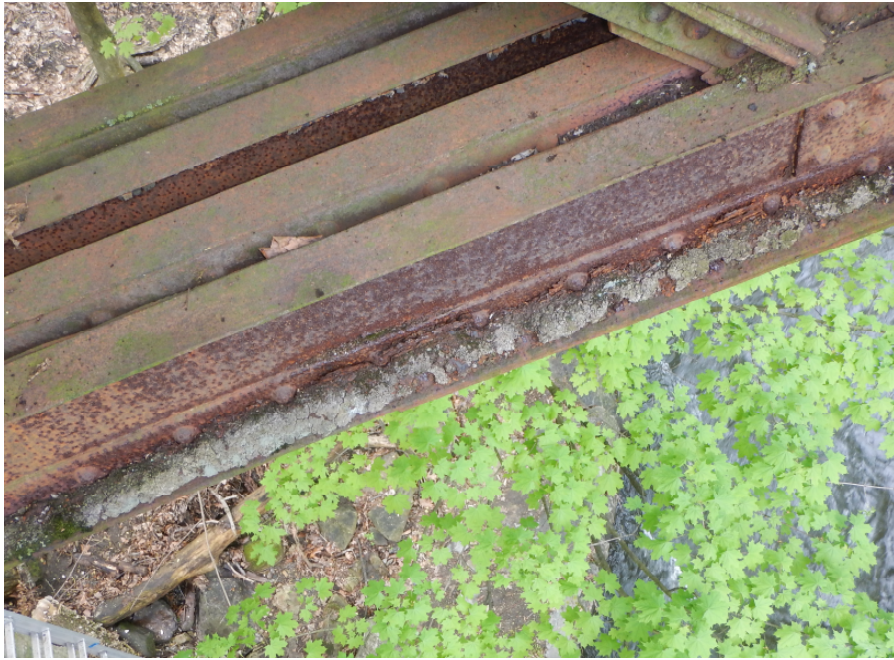
Photo 15: Severe corrosion and section loss to Span 2, Center Truss lower chord member L1L2, looking down.

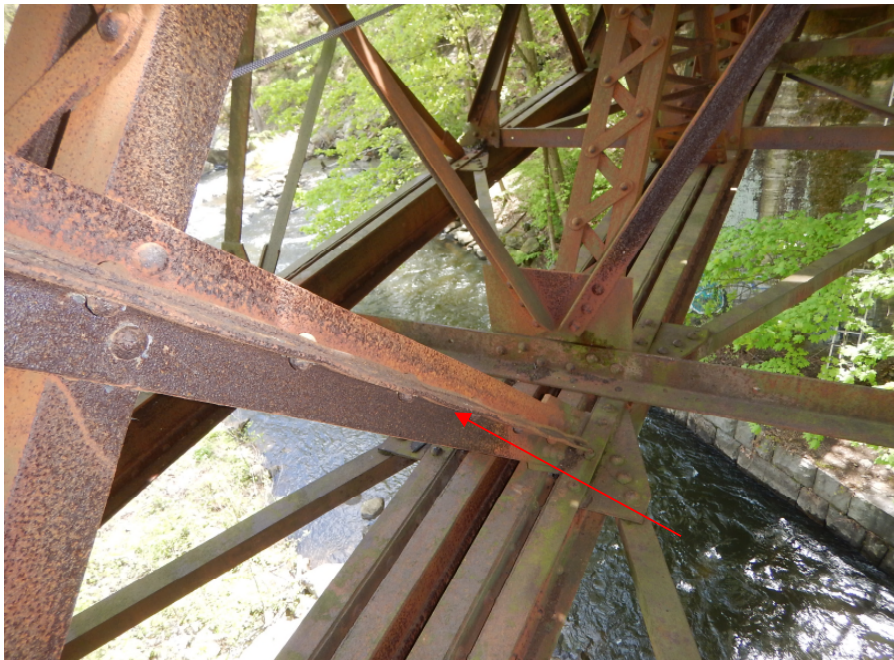
Photo 16: Typical condition of truss members, Span 2 Center truss, looking north. Note pack rust between riveted angles.

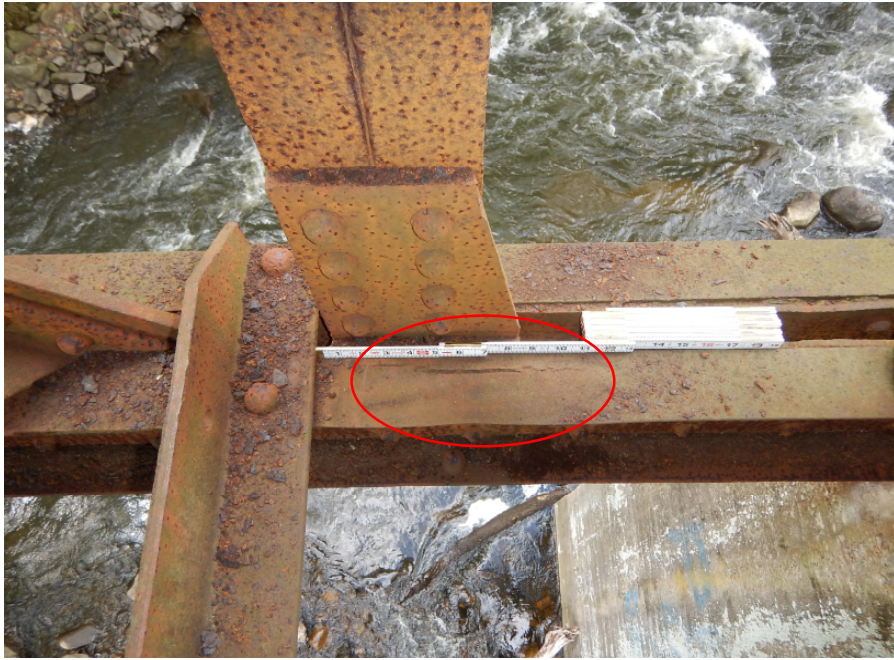
Photo 17: 10" long crack in horizontal leg of Span 2, West Truss lower chord member L7L8 at L7, looking west.

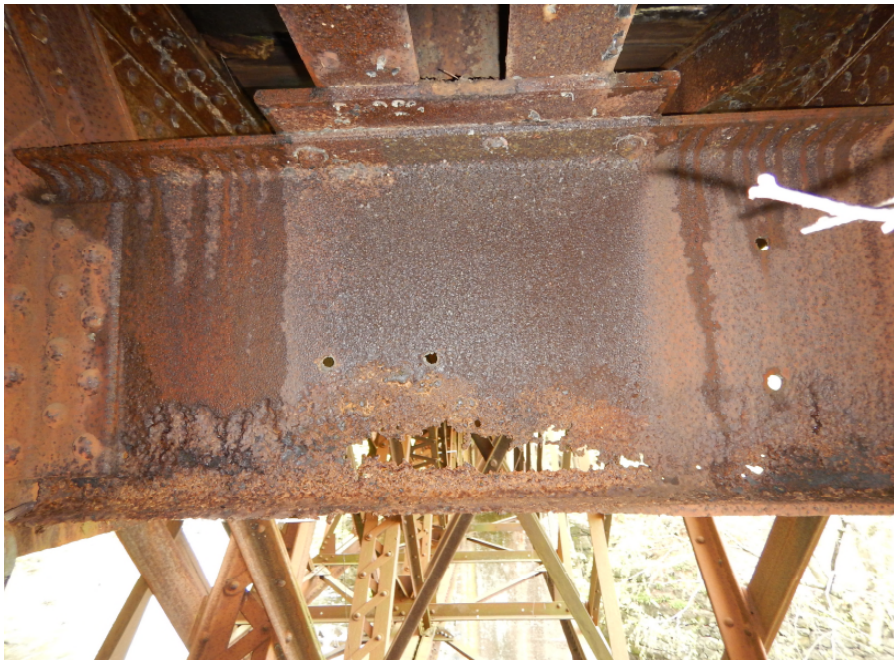
The steel floorbeams supporting stringer spans between the truss spans exhibit moderate to severe corrosion with numerous large holes in the floorbeam web (See Photo 18).

Photo 18: Large web hole and lower flange section loss at end floorbeam at U1, Span 2 between Center and West Trusses, looking north.

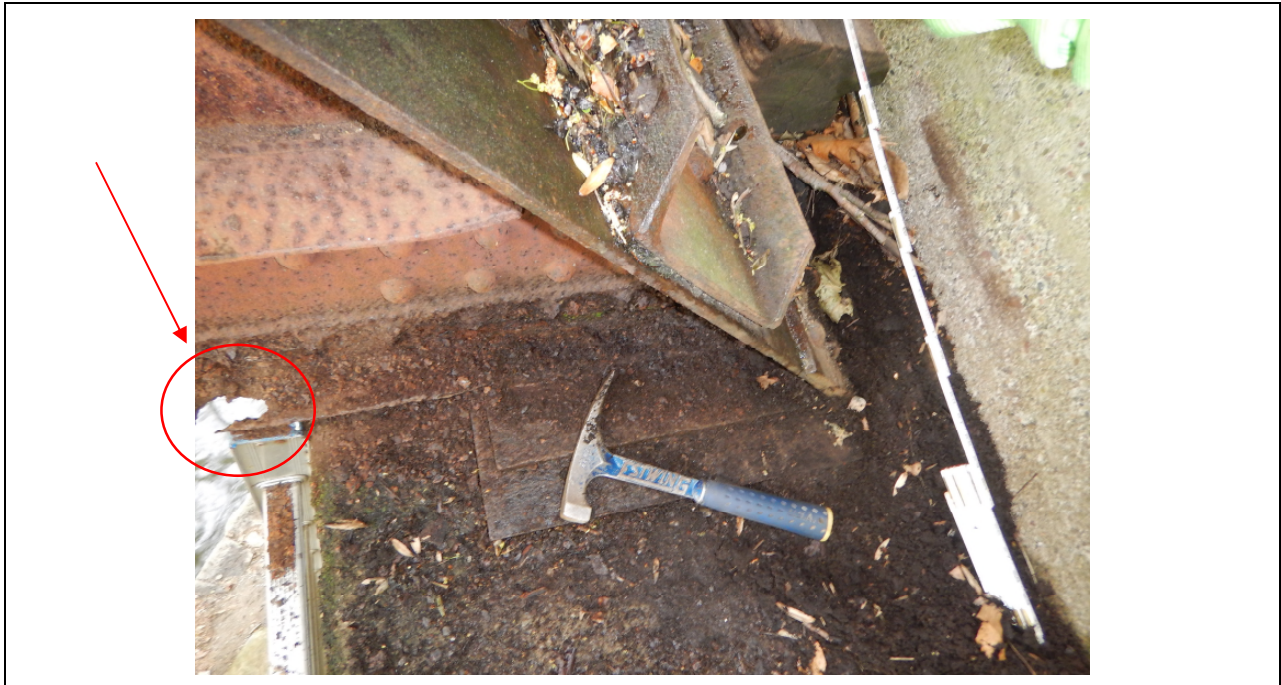
The steel truss sliding plate bearings exhibit severe corrosion with heavy accumulation of dirt and debris covering the bearings (See Photo 19).

Photo 19: Heavy dirt and debris accumulation at truss bearing over Pier 1, looking west. Note large hole in lower chord member L0L1 at West Truss.

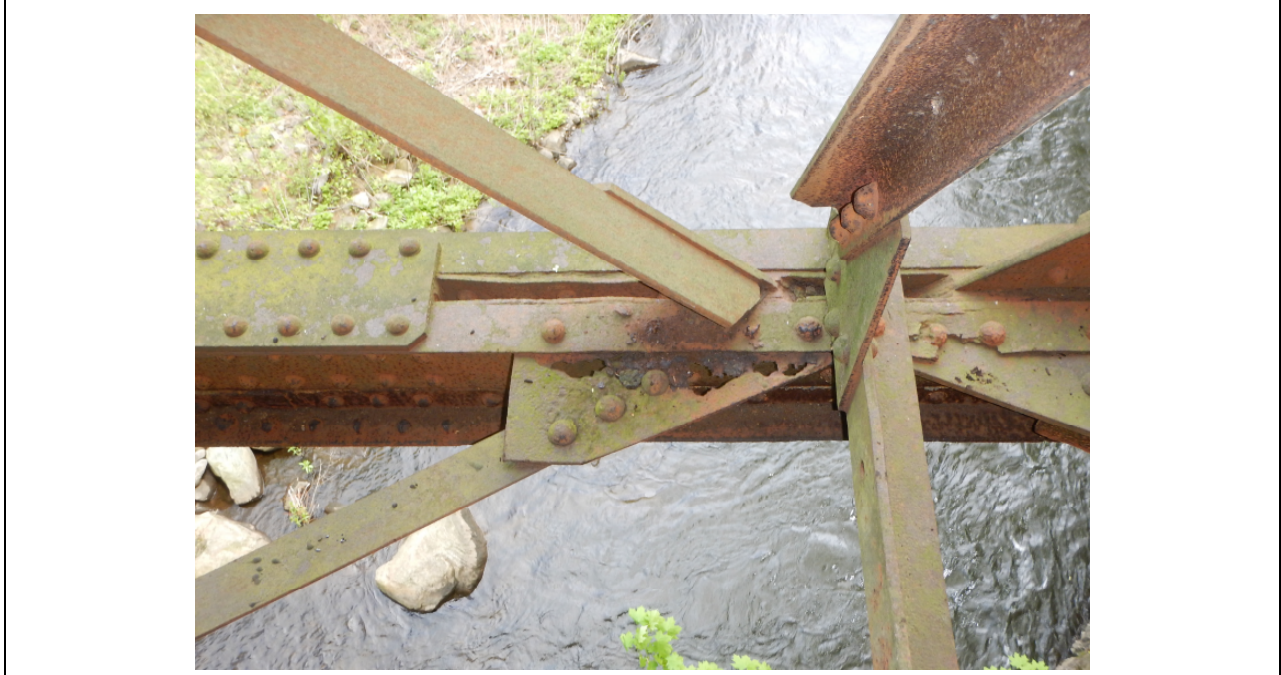
The lower horizontal bracing exhibits moderate to severe corrosion with numerous members disconnected and 100% section loss to several of the horizontal gusset plates (See Photo 20).

Photo 20: 100% section loss to truss lower horizontal bracing at Span 2, East Truss L2, looking down.

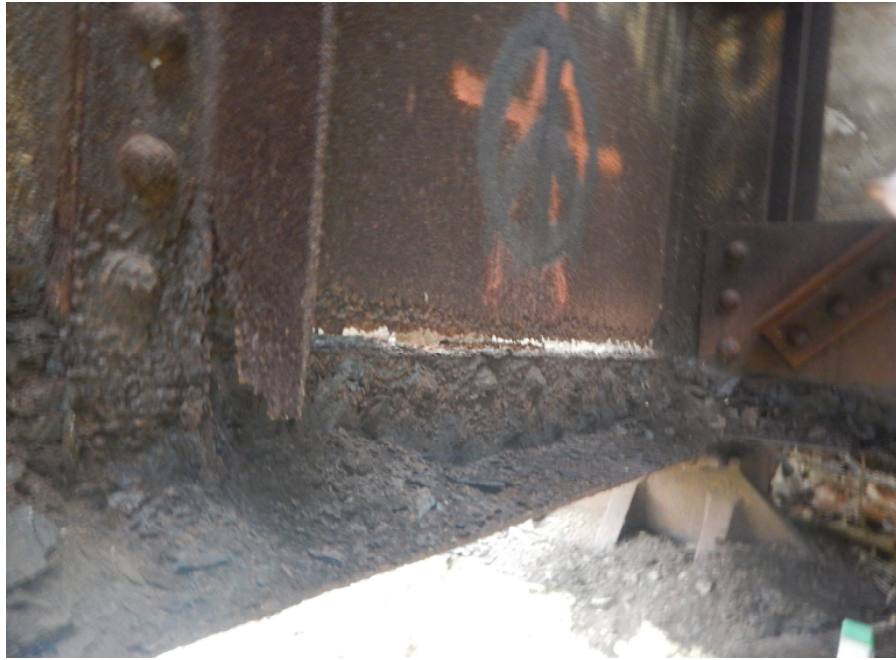
- Vertical web stiffeners typically exhibit large holes near the bottom flanges (See Photos 21 & 25).
- Severe section loss with 100% section loss at several locations along bottom flanges (See Photo 24).
- Girder 2 in Span 1 exhibits a large web hole (40" long x 2" high) near the South Abutment (See Photo 21).
- Lower horizontal bracing exhibits severe section loss with up to 100% section loss (See Photos 22 & 23).

Photo 21: 100% section loss and holes in girder web and vertical stiffeners, Span 1 East Girder at South Abutment, looking southeast.

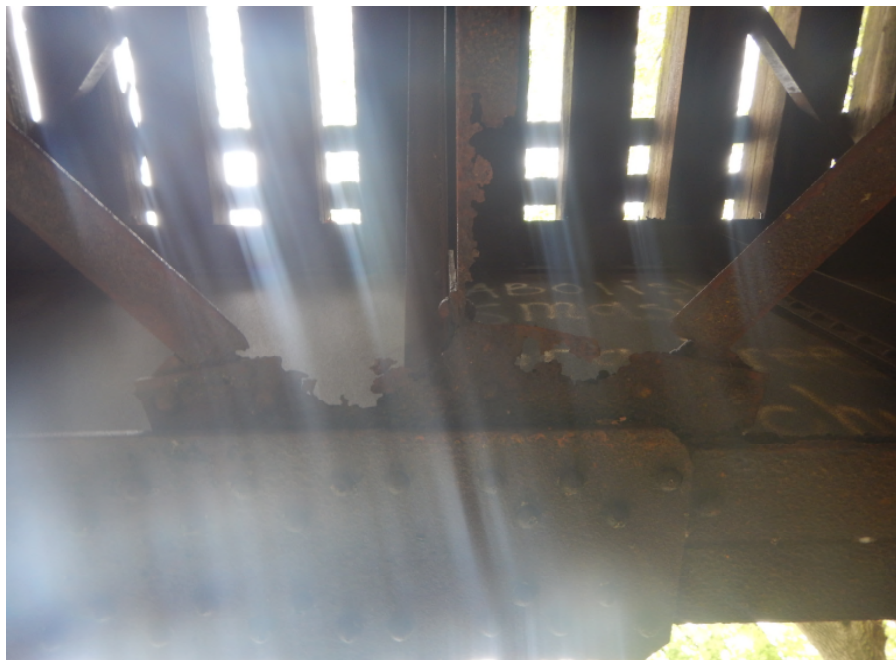
Photo 22: Severe corrosion and 100% section loss to lower horizontal bracing members, Span 2 at West Girder, looking west.

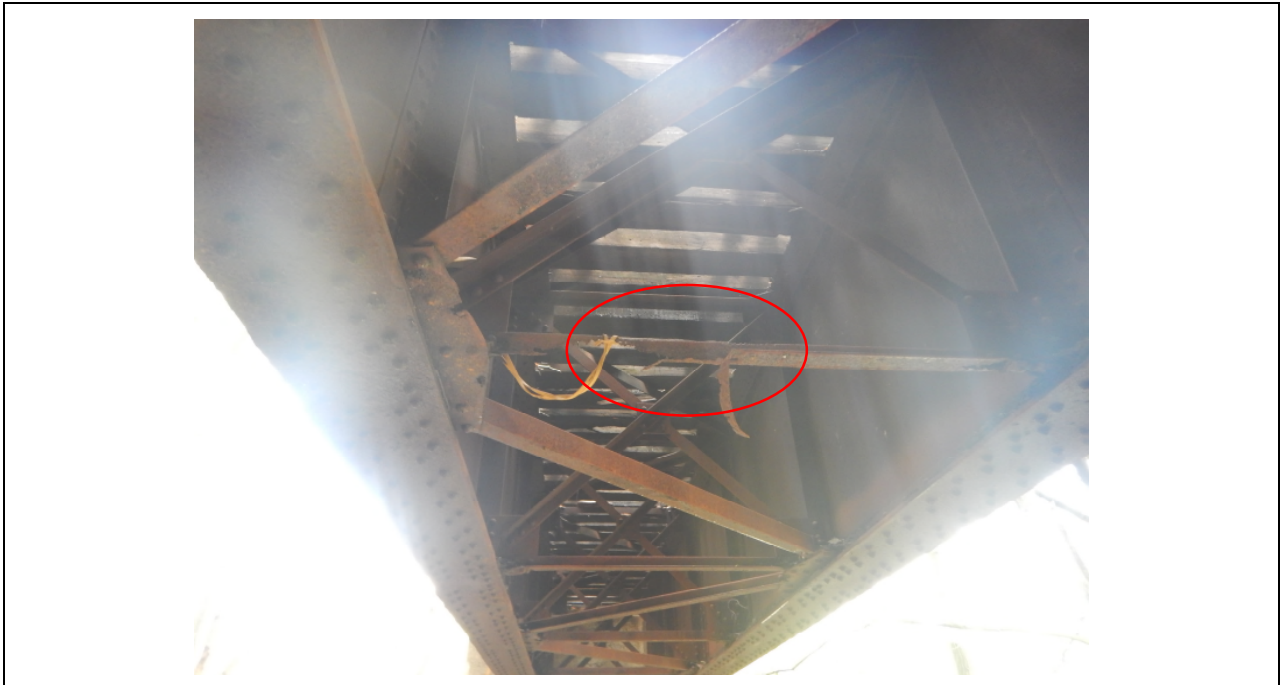
Photo 23: Underside of Span 1 deck girders, looking north. Note severe corrosion to horizontal cross bracing.

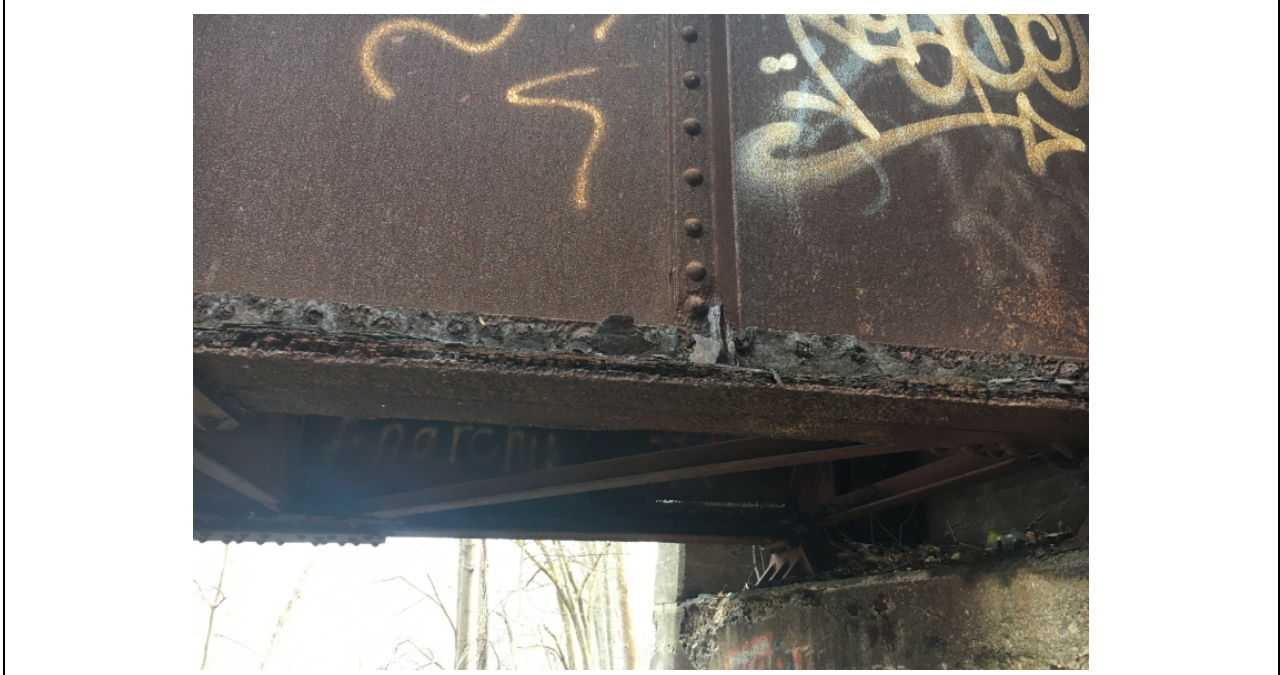
Photo 24: Severe corrosion to bottom flange angles, Span 1, West Girder, looking east.

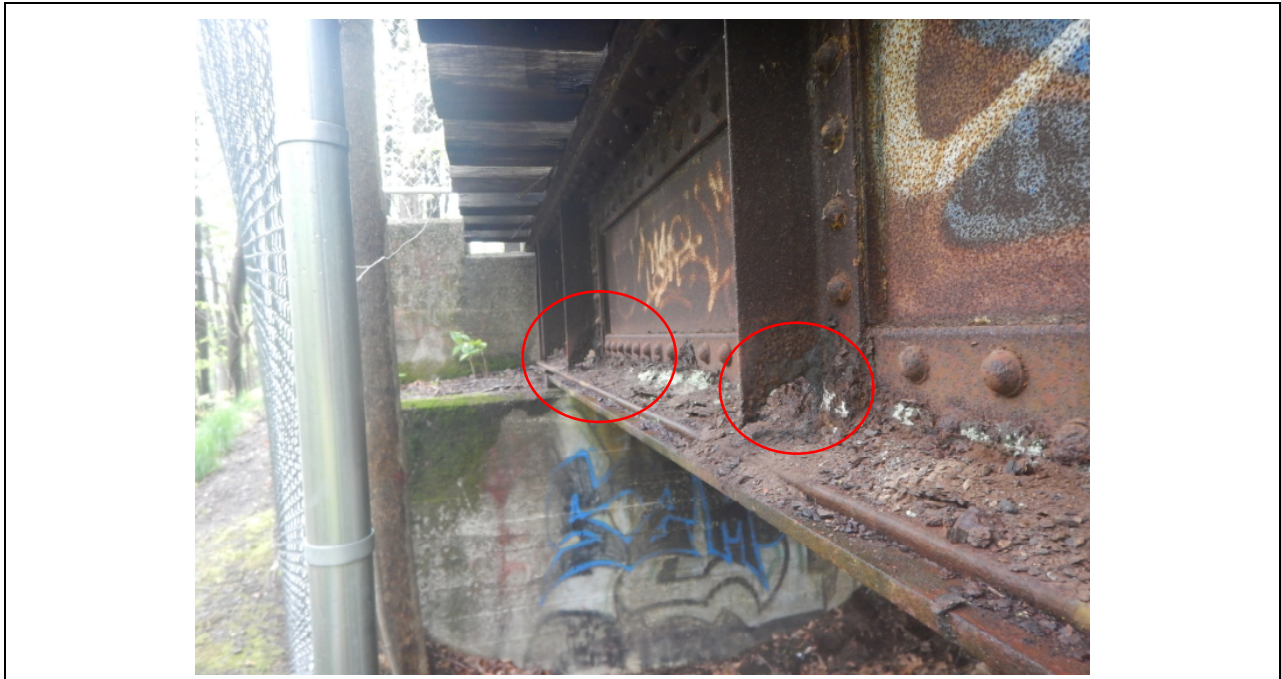
Photo 25: 100% section loss to vertical stiffeners, Span 4, West Girder, looking north. Note heavy debris on girder bottom flange.

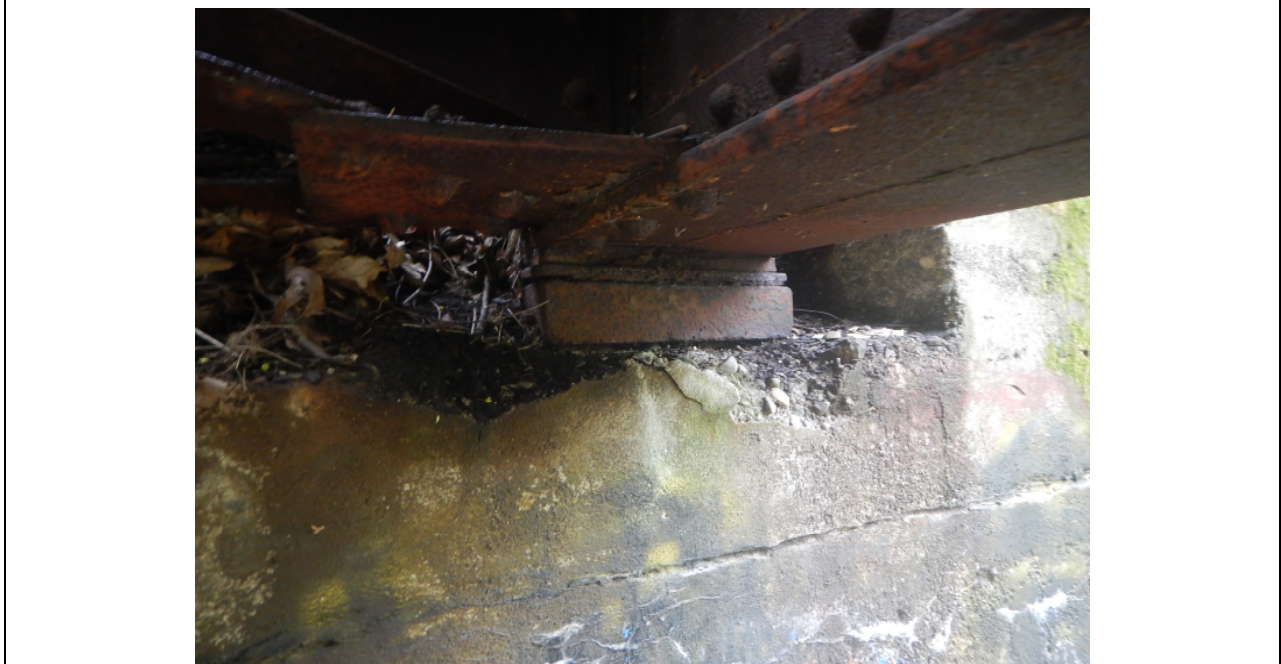
The substructure is in satisfactory condition with moderate to severe scaling and spalling throughout the concrete elements (See Photos 26, 27, & 28). Moderate erosion was noted at the west embankment adjacent to the South Abutment (See Photo 29).

Photo 26: Large spalls in Pier 3 seat below girder bearing, looking south.

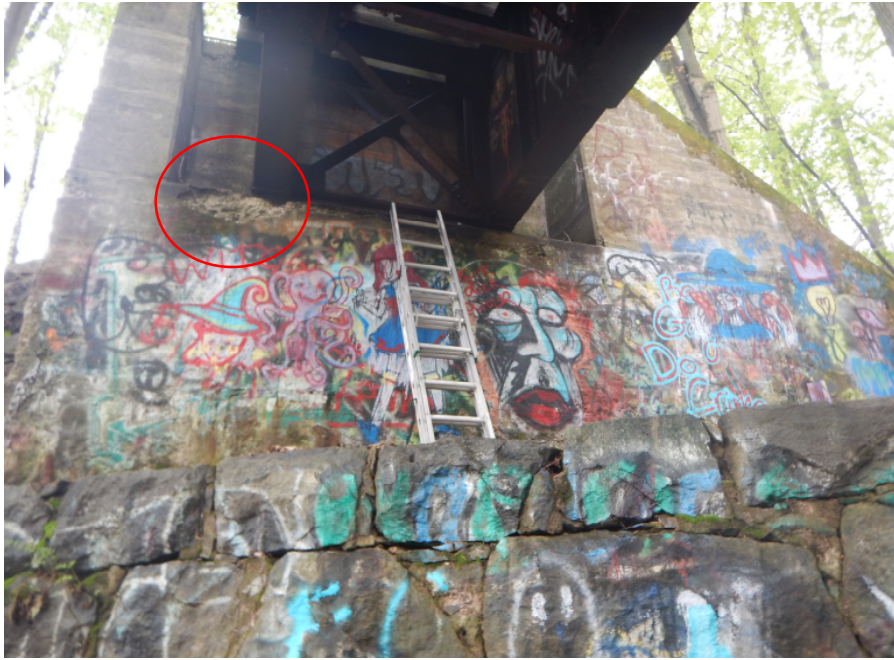
Photo 27: Spall in South Abutment seat, looking south. Note heavy graffiti on abutment breastwall.

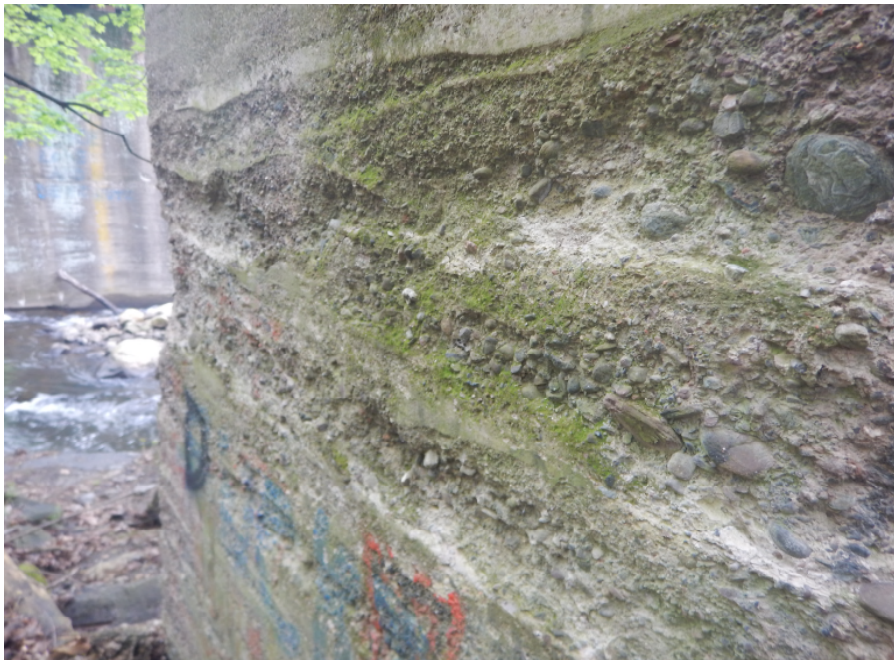
Photo 28: Heavy scaling to west face of Pier 1, looking north.

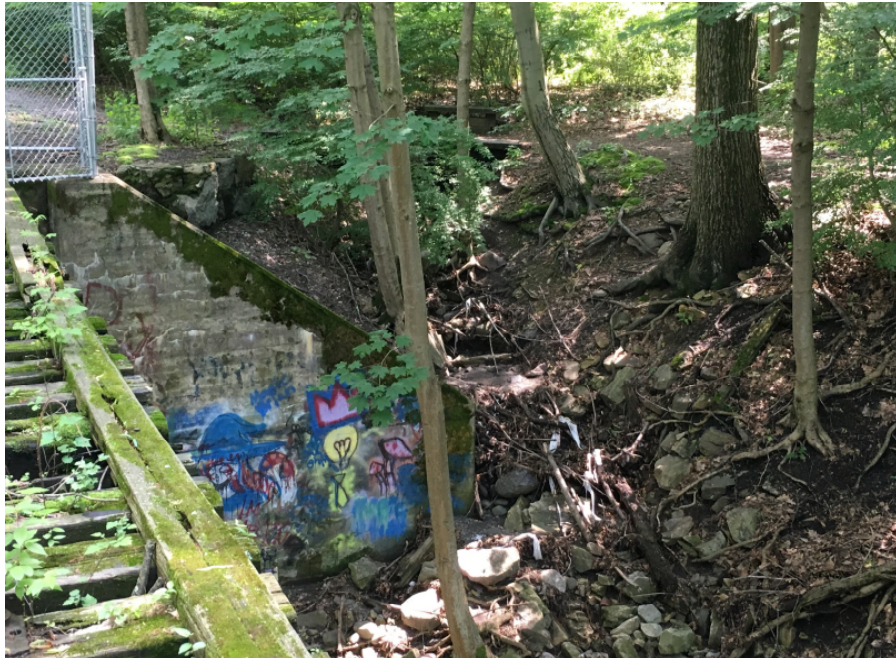
Photo 29:

Severe erosion along west embankment of South Abutment, looking south.

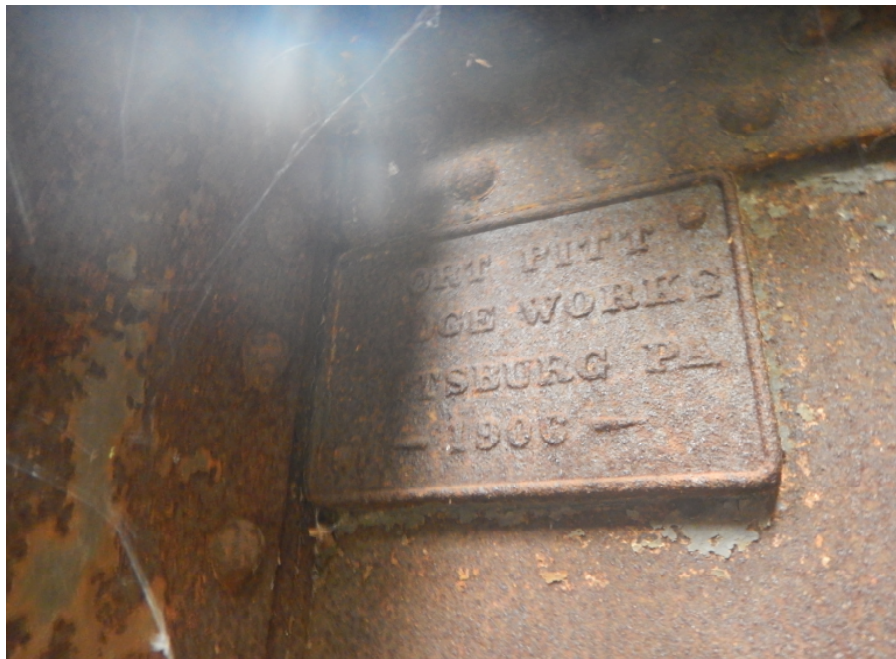
Photo 30:

Bridge plaque on girder span, "Fort Pitt Bridge Works, Pittsburg PA, 1906".
